Lost Radioactive Source Capsule January 2023

Presentation to ARPS 2023

Frank Harris Chief Advisor Radiological Governance

June 2023

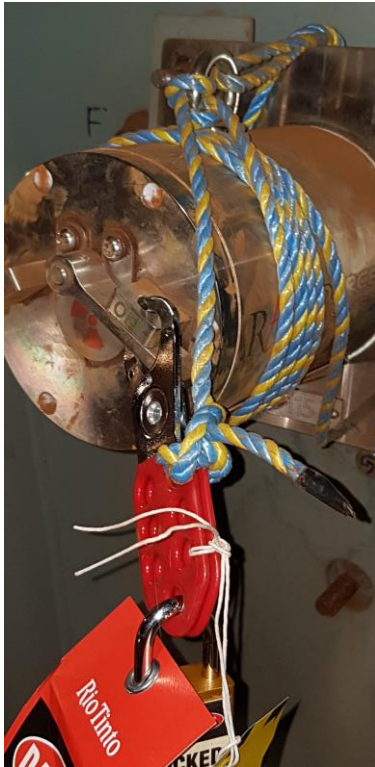
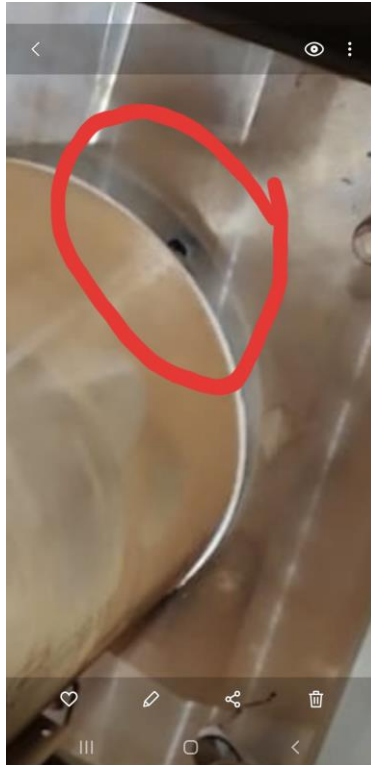
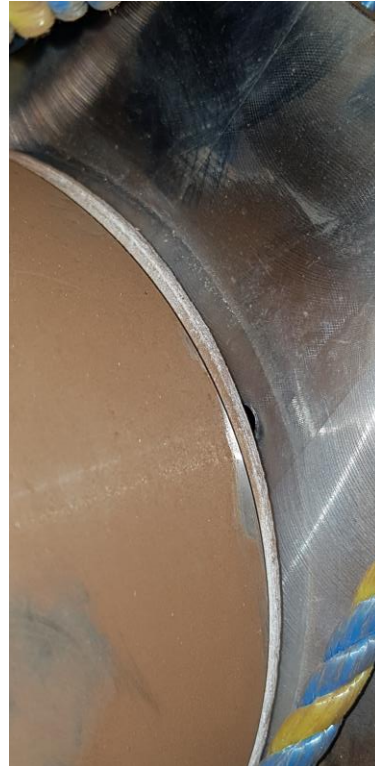
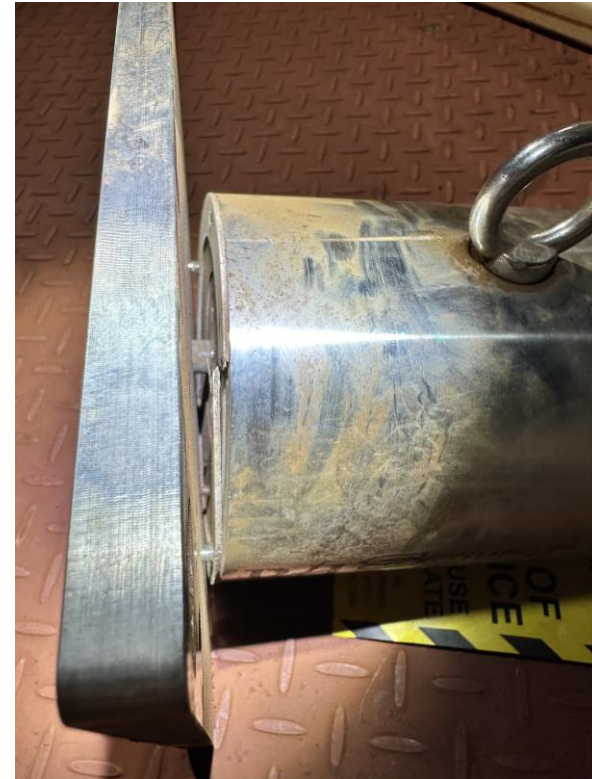
Checking other gauges

- Rio Tinto placed freeze on all gauge transportation until investigated
- Examination of all gauges within Rio Tinto Iron Ore
- Examination of all gauges of similar design (WA Radiological Council directive)
- Communication with other State Agencies recommending similar examination (WA Radiological Council)

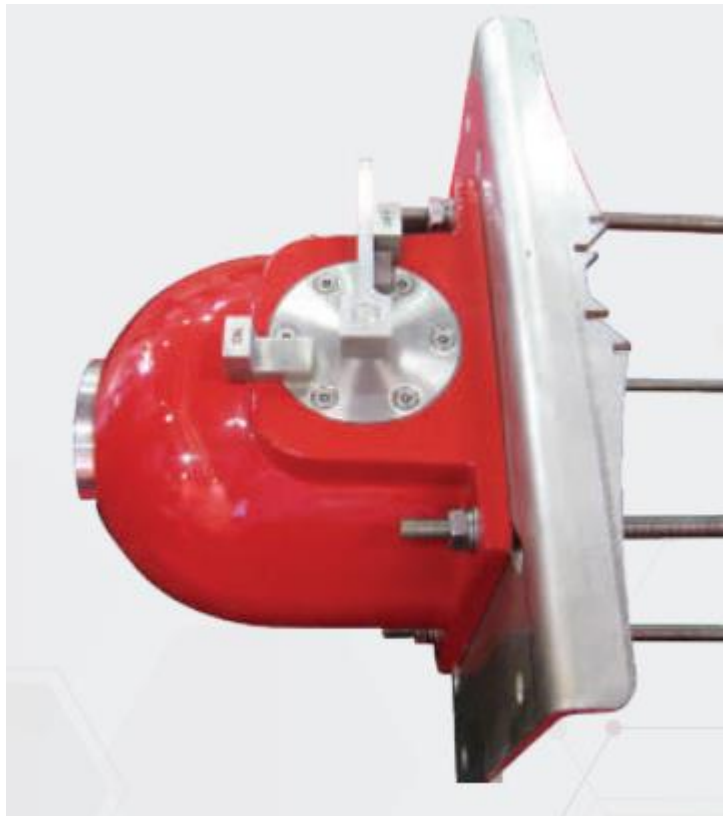
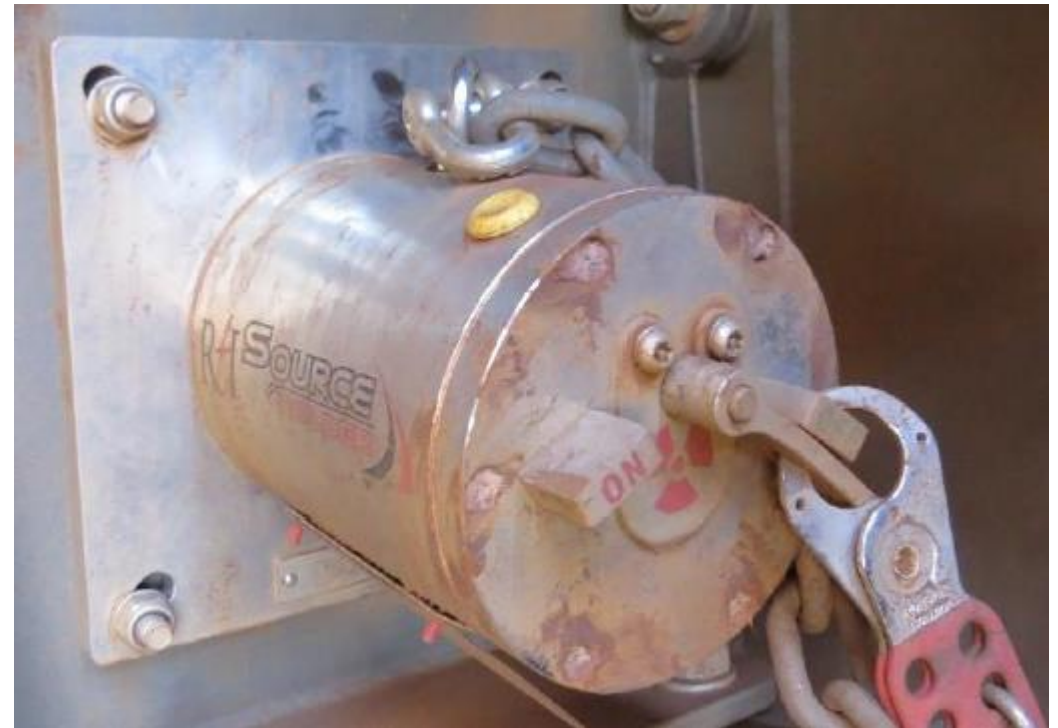
Gauge Design

- The “new” gauge designed moved from the historic cast construction to an engineered structure with the outer casing consisting of a cylinder attached to a front and back end plate
- The structure is held together by 12 M5*15mm bolts (6 at the front and six at the back)

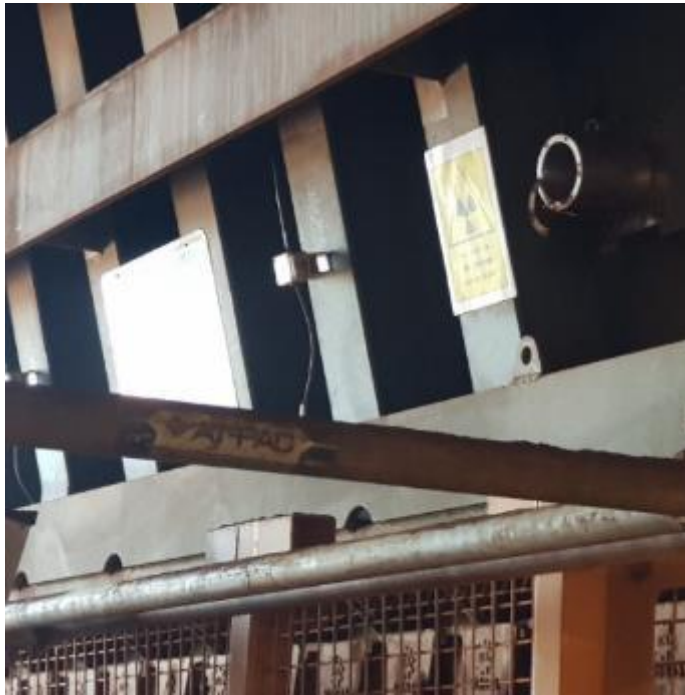
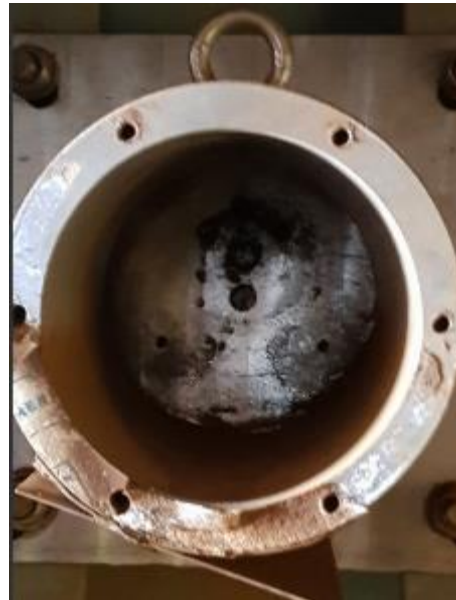
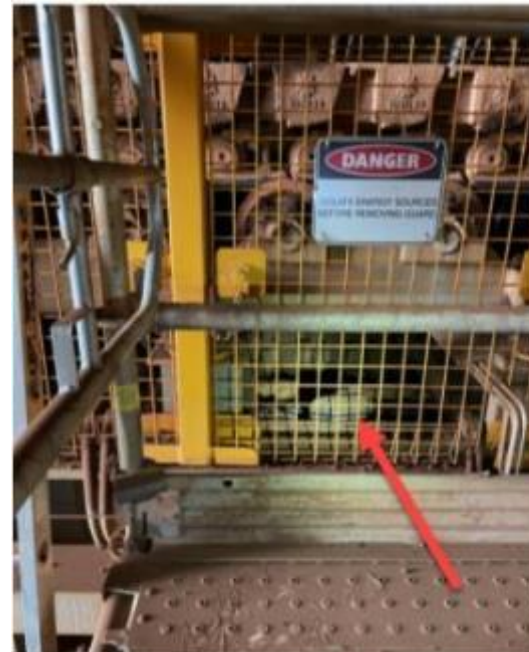
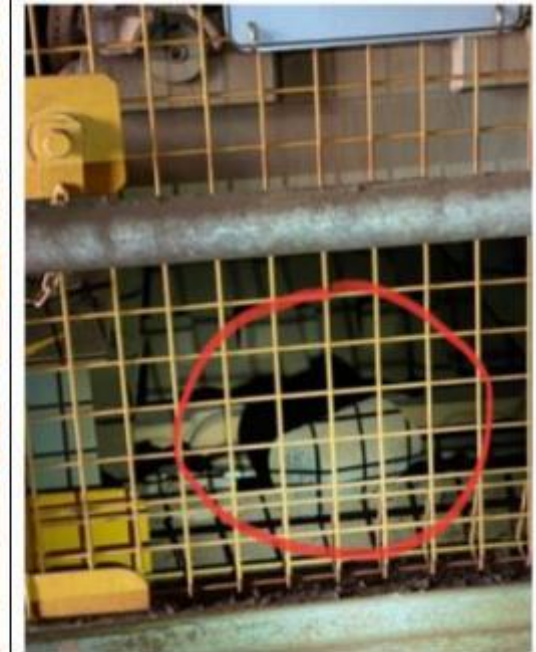
First Incident

- The top plate had totally separated from the rest of the housing. Bolts were NOT sheared off and appeared to have just come undone
- Shield housing still contained the source capsule and was found approximately 2m below

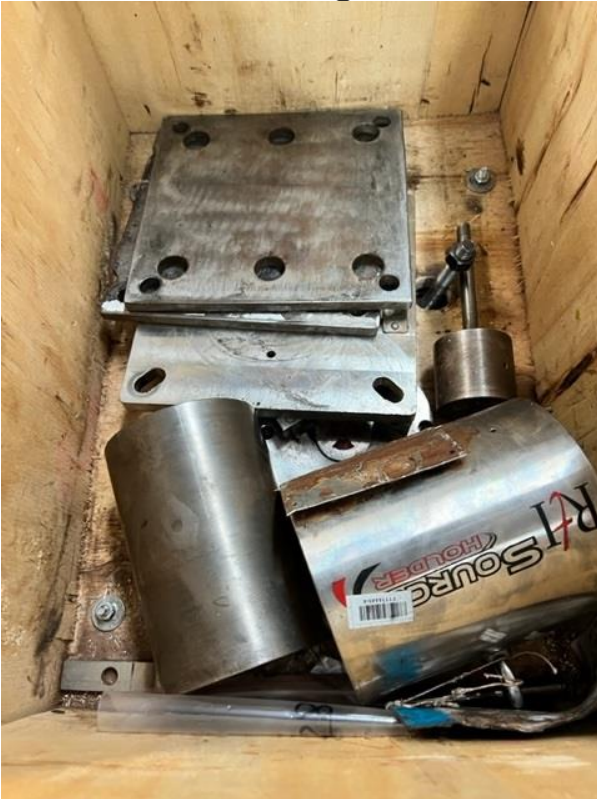
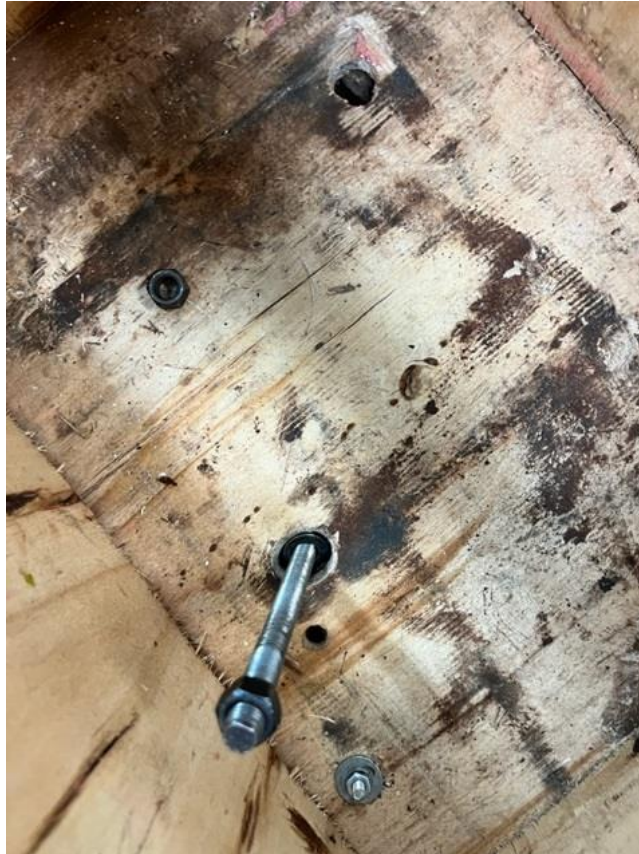
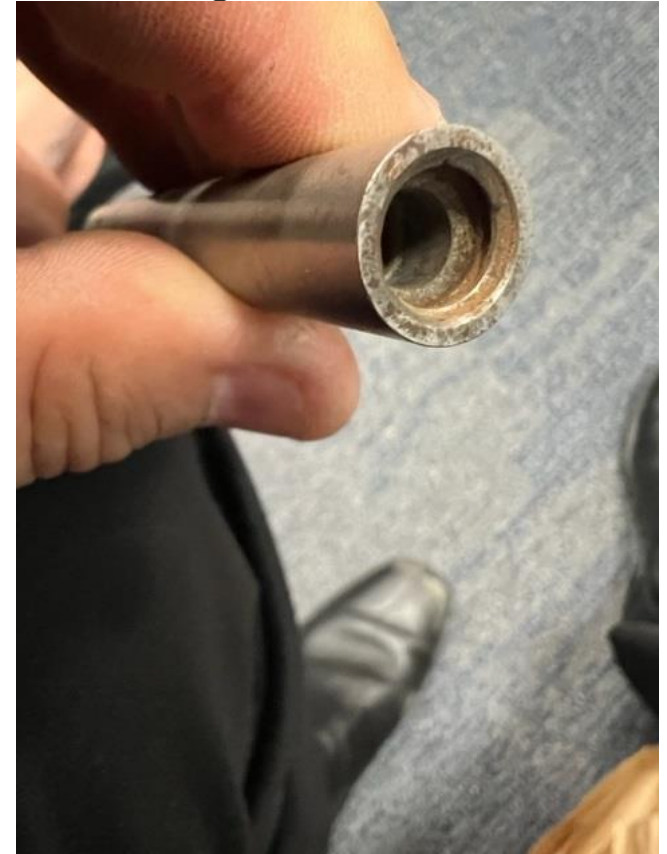
Second Incident

- The gauge basically shook itself into its component pieces in the overpack
- One of the two mounting bolts vibrated loose, enlarged its hole and left this enlarged hole as a overpack penetration
- Even the locking bolt at the end of the source rod holder was unscrewed and missing

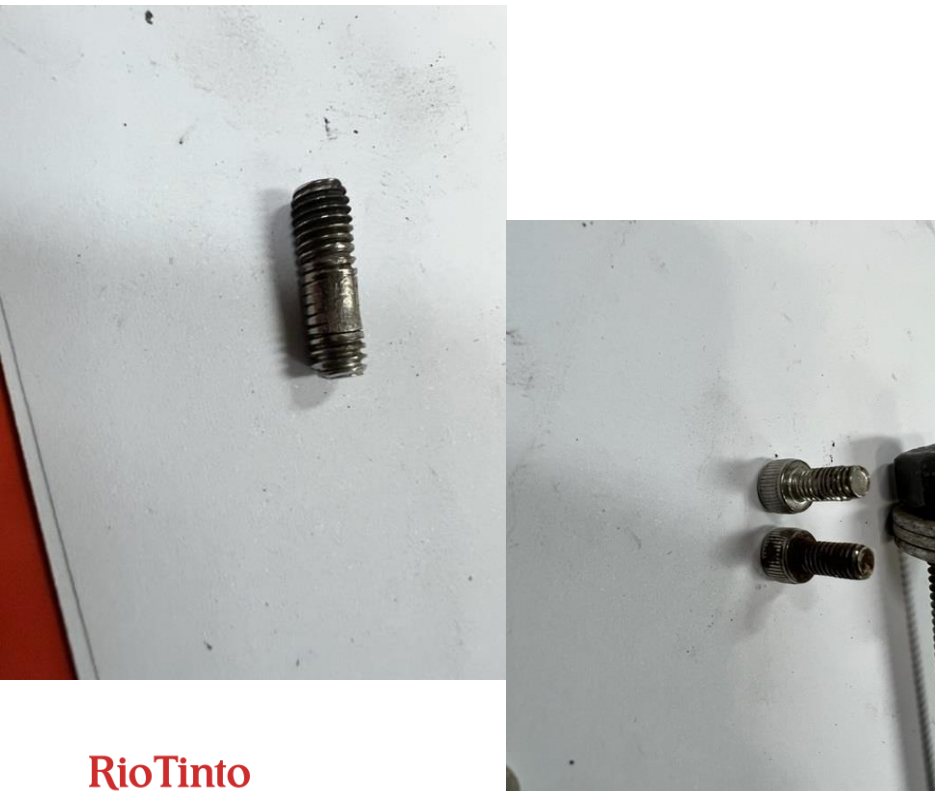
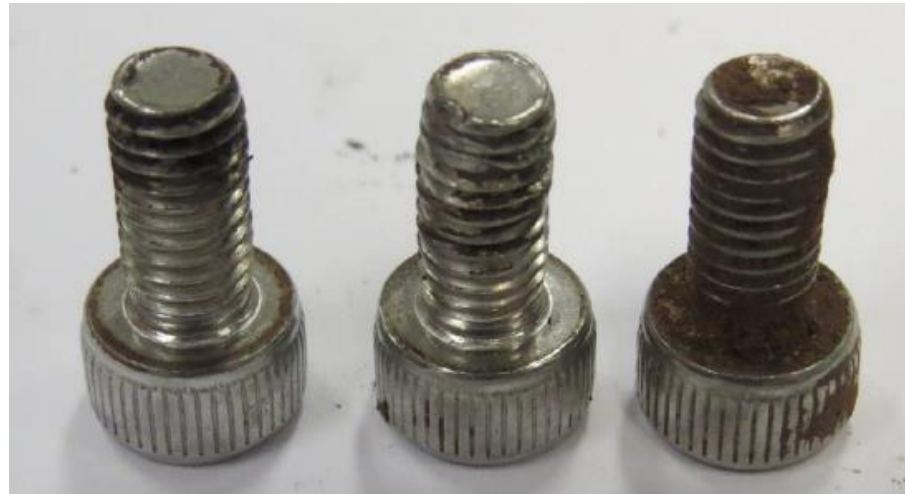
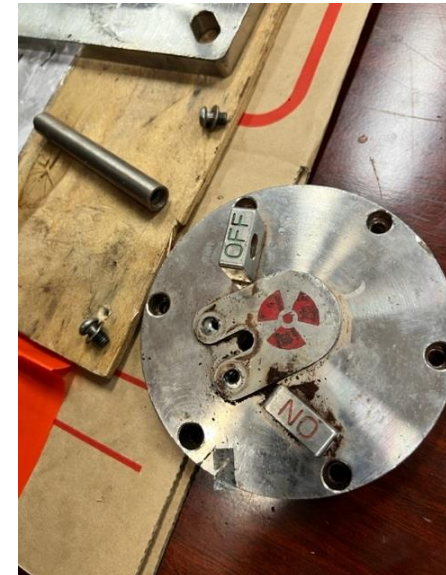
Bolts and attachment

- Only one bolt remained attached for either the top or bottom plate and it was sheared off (a case of last man standing)
- Other bolts found show damaged threads
- Only remaining bolts in the source cover on the top plate were so loose they could be undone by hand

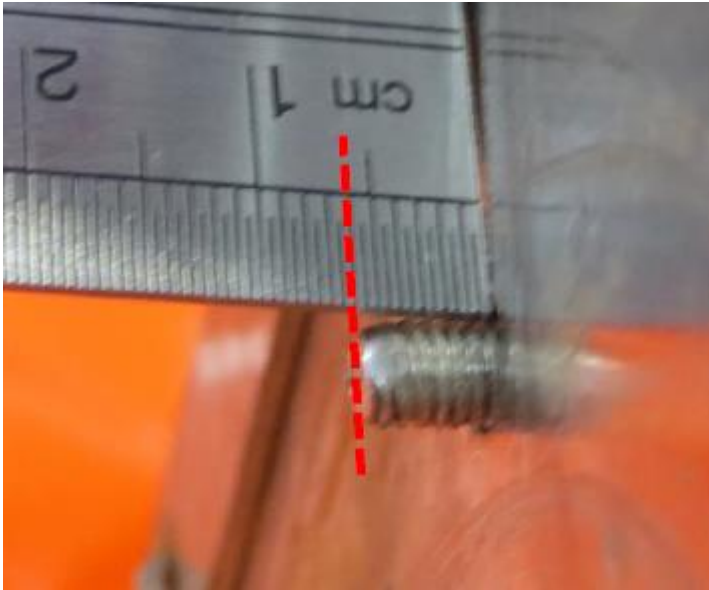
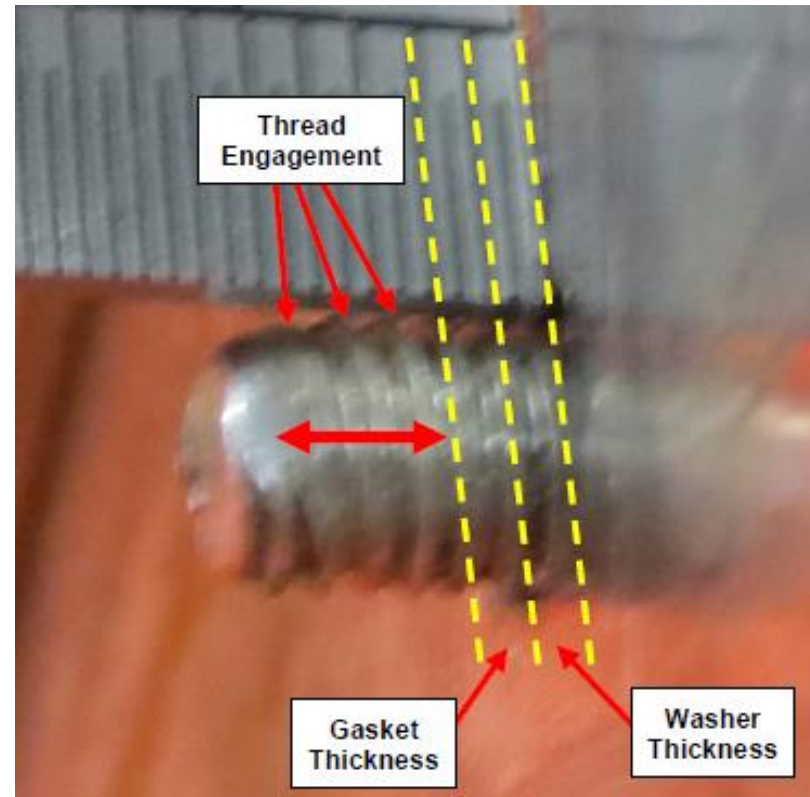
On a short thread

- The bolts utilised for the structural integrity of the gauge relied on only a few turns of thread
- The only design component for vibration was the use of spring washers (no nylon lock nut, Loctite, epoxy resin, etc.)
- Recommended tightening torque obtained from manufacturer during reassemble very low (3 Nm)

- More rigorous and comprehensive mechanical design and manufacturing consideration of vibration
- Testing of gauges for vibration as the current guide is a bit uncertain on whether the gauge as a whole or just the source capsule needs vibration testing

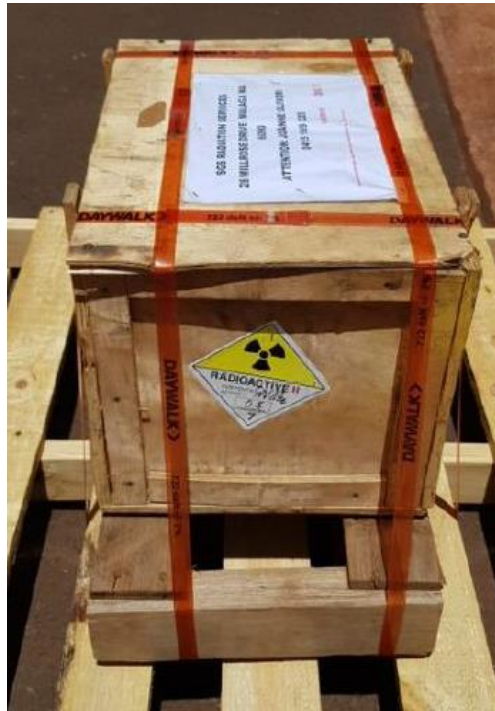
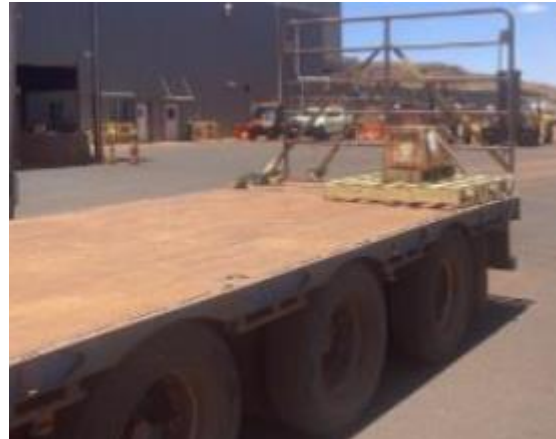
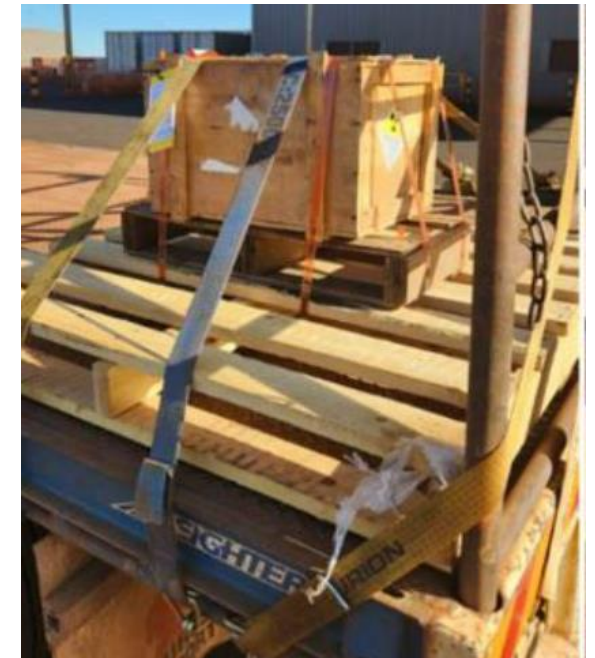
Packaging

- Rio Tinto contracted a licensed and experienced firm to reassemble the gauge and package it for transport
- The gauge was attached to the base of the overpack using two bolts (in a similar way to how new gauges are sent from the manufacturer)
- No additional packaging or precautions were taken despite the gauge being previously damaged with the exception of some additional steel plates at the base (for additional shielding due to shutter being broken)
- The overpack was placed at the rear of the rear trailer of a B Double truck

- More consideration of vibration as a potential cause for loss of containment needs to be added
- The status and integrity of a damaged gauge or source container need to be considered and if the original package type rating is still maintained
- Solid and robust
- Examine a requirement for checking the source is in place (such as comparing the pre and post Transport Index) upon receipt of an item which is not part of routine transport or where there is any damage either before or during transport
