Lost Radioactive Source Capsule January 2023

Presentation to ARPS 2023

Frank Harris Chief Advisor Radiological Governance

June 2023

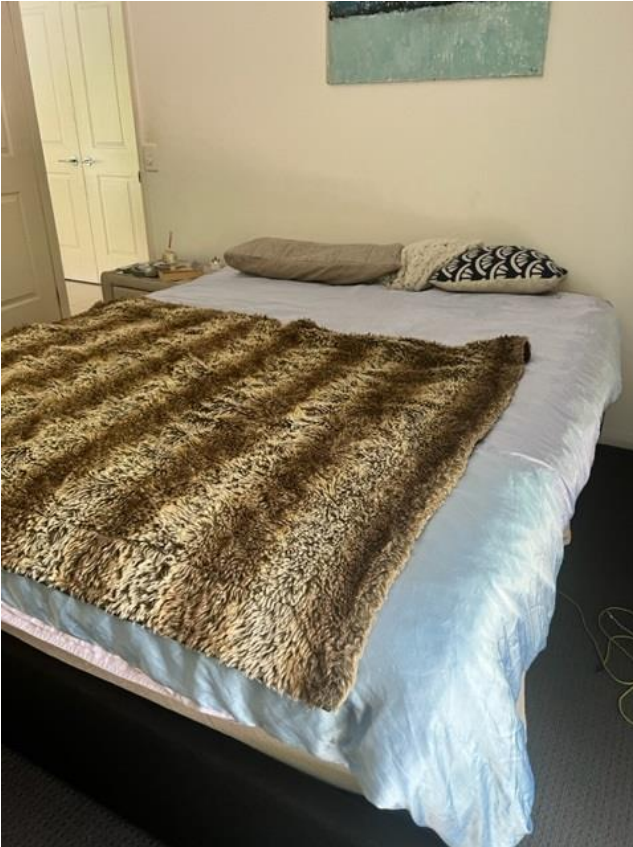
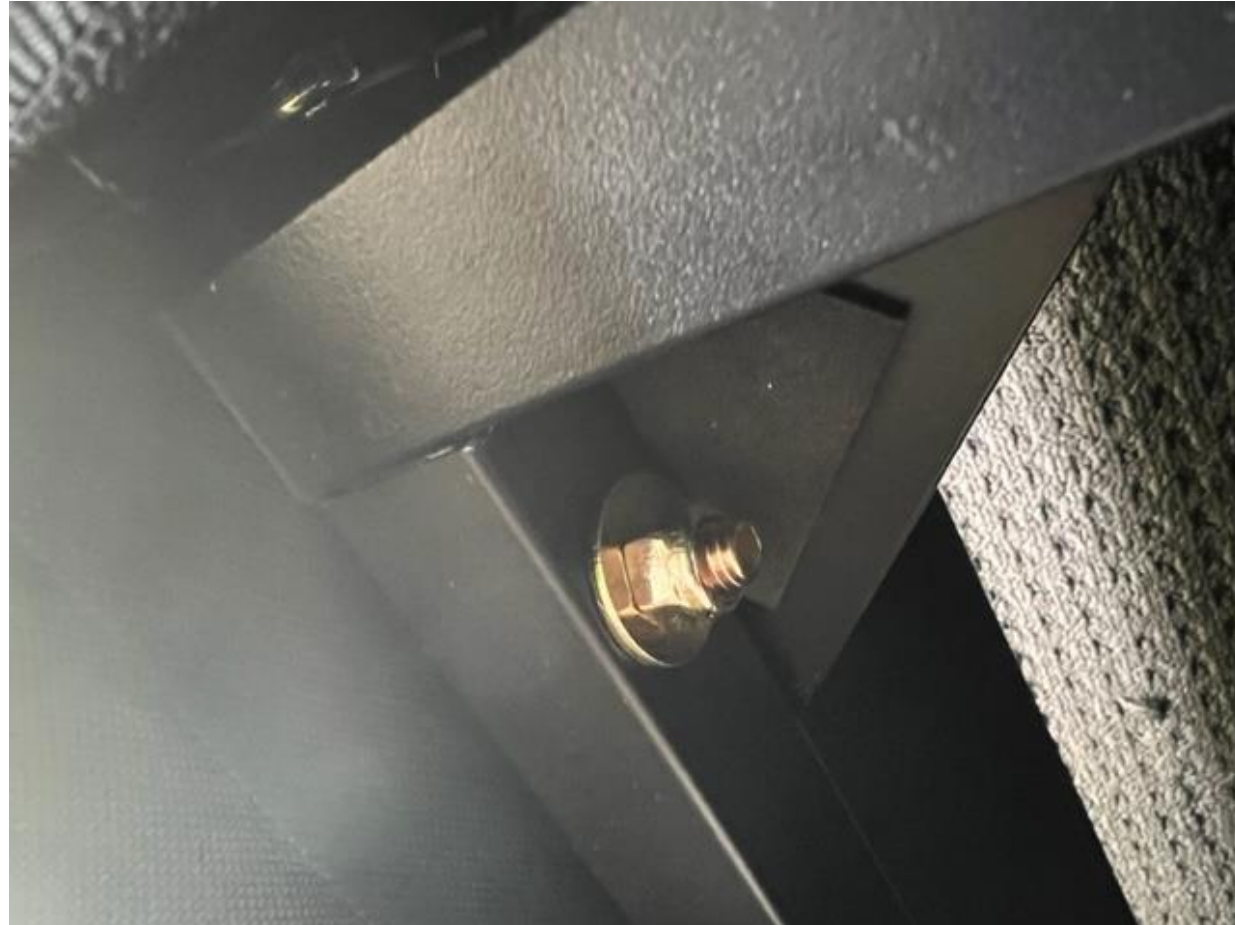
Vibration!!!!!!

- Vibration is a well known potential cause of failure in mechanical components where screws or bolts are used
- Even common items which may be exposed to vibration are protected
